**HARBOR HOUSE CAMDEN CONDOMINIUM ASSOCIATION  
ELEVATED DECK EVALUATION REPORT  
CAMDEN, MAINE**

Report Issue Date: November 5, 2025  
Project Number 23-0473

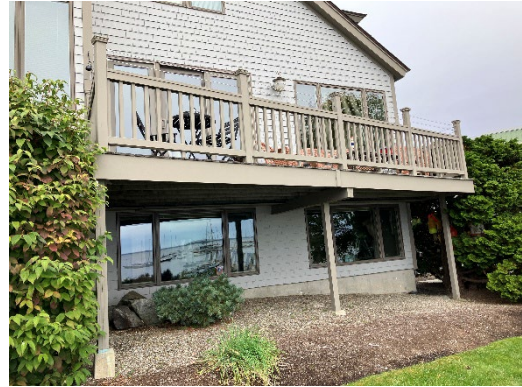
- South 2x8 ledger/edge beam is cracked along length; ledger has holes from prior anchors which were removed and the holes filled with spray foam
- Posts are offset from pier center points

- Ceiling inhibits observation of condition along west edge of deck at building; debris and moisture are likely trapped where joists run north-south
- PT wood is stained and weathered but not degraded

- (2) notched guardrail posts are split with some wood missing at thru bolts (inadequate edge and edge distances); prior 1x3 repair is inadequate
- Guardrail is degraded and cables are loose (non-compliant, >4" spacing)
- Guardrail is wobbly
- Decking is weathered

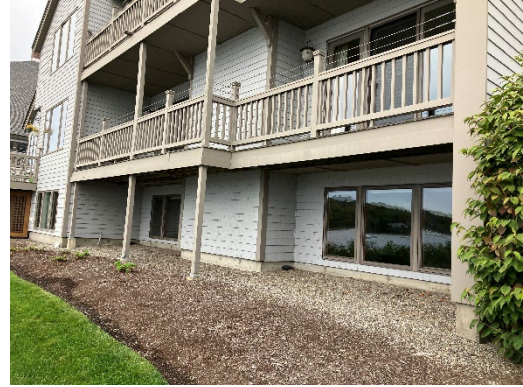
**Deck No. A2-1E****Configuration**

- Posts are offset from pier center points
- Ceiling inhibits observation of condition along west edge of deck at building; debris and moisture are likely trapped where joists run north-south

- Nails attaching edge joist in center bay to building are too short to penetrate structure; 1 spacer block missing (or fell out)
- Spacer block at north ledger is loose

- Nuts and washers on guardrail threaded rod are loose in at least (1) location
- Guardrail is degraded and cables are loose (non-compliant, >4" spacing)

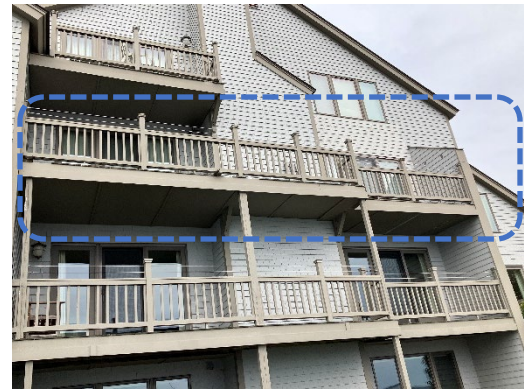
- Posts do not appear to have caps or straps; connections appear to be toe-nailed
- Poor quality PT material used
- Ceiling inhibits observation of condition along west edge of deck at building; debris and moisture are likely trapped where joists run north-south

- Some ledger anchors are loose
- Some ledger anchors appear to be bent (heads rotated)
- West edge joists are attached to ledger with one Simpson LS70 or (2) Simpson A23Z stacked (one side); most are rotated and have apparent gaps at the connectors

- North diagonal brace is split; ceiling around brace is sagging
- Tops of joists are split due to excess decking fasteners penetrations over the years
- Guardrail is degraded and cables are loose (non-compliant, >4" spacing)

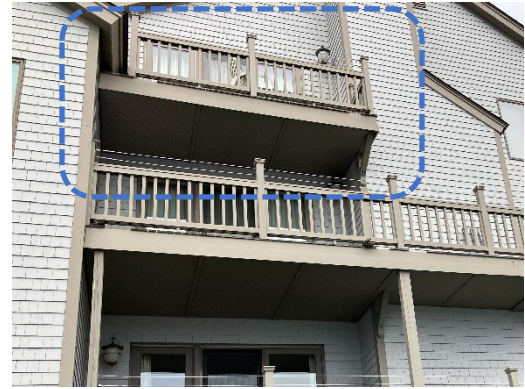
- Ceiling inhibits observation of condition along west edge of deck at building; debris and moisture are likely trapped where joists run north-south
- Plies of (2) 2x8 PT edge beam are not fastened together
- Connections are deficient
- Diagonal brace lacks reliable load path
- Tops of joists are split due to excess decking fasteners penetrations over the years
- Guardrail is degraded and cables are loose (non-compliant, >4" spacing)
- Guardrail is wobbly
- Flashing at west edge joist around door appears deficient

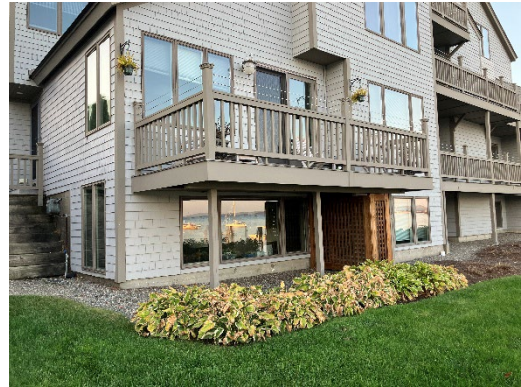
- (4) unfilled holes are drilled through south end of ledger (purpose unknown)
- Posts are offset from pier center points
- Inner ply of dropped beam is spliced within beam spans
- Edge joists do not bear on dropped beam
- Guardrail is wobbly
- Guardrail is degraded and cables are loose (non-compliant, >4" spacing)

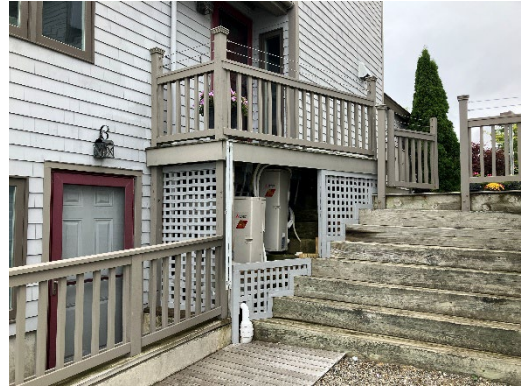
- Two of three full length joists are notched 2 1/2" deep for approximately 32" (long) near midspan to accommodate the mechanical unit below the deck
- Posts have minor material degradation ("soft")
- Joists at southeast corner are headered oddly; load path is indirect
- Guardrail is degraded and cables are loose (non-compliant, >4" spacing)

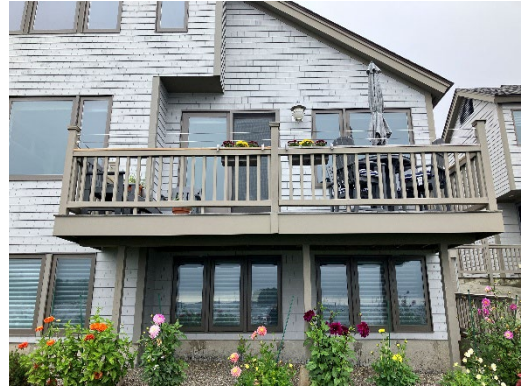
**Deck No. B5-1E****Configuration**

- Posts are offset from pier center points
- Inner ply of dropped beam is spliced within beam spans
- Edge joists do not bear on dropped beam
- Guardrail elements are degraded; guardrail has been reinforced but remains wobbly; guardrail cables are loose (non-compliant, >4" spacing)

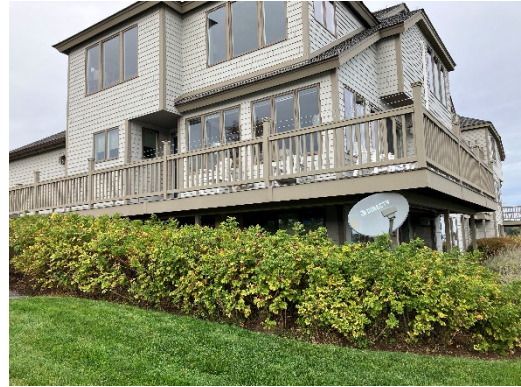
**Deck No. C14-1E/S****Configuration**

- Failed joist hangers at west end of deck; hangers have corroded through entirely
- Severe post cap and post base corrosion
- South support beam hanger is corroded at southeast corner connection
- Inner ply of dropped beam is spliced within beam spans
- West ledger is split; ledger anchor bolts appear to be crushing into ledger
- Beams appear deflected
- Posts are offset from pier center points
- Edge joists do not bear on dropped beam
- Guardrail is wobbly
- Guardrail is degraded and cables are loose (non-compliant, >4" spacing)
