**HARBOR HOUSE CAMDEN CONDOMINIUM ASSOCIATION  
ELEVATED DECK EVALUATION REPORT  
CAMDEN, MAINE**

Report Issue Date: November 5, 2025  
Project Number 23-0473

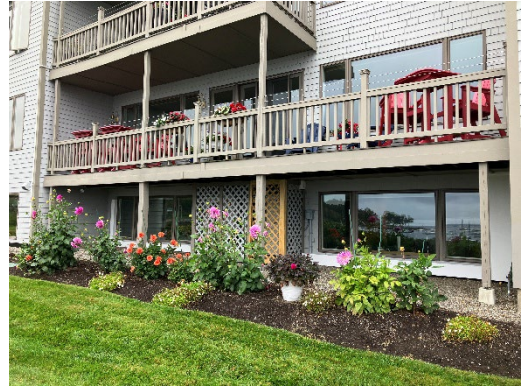
**Deck No. B6-1E****Configuration**

- First story, rectangular deck extending full width of building alcove with 2 decks above (B7-2E and B7-3E)
- Mechanical units with attached enclosure below deck
- 1 round vent (approximately 4" dia.) and 1 rectangular vent (approximately 3"x10") at south end of ledger (rusted)

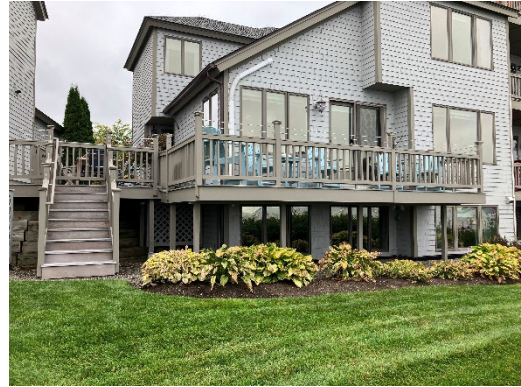
**Deck No. B8-1E/S****Configuration**

- Single level, first story, wrap-around deck with ramp section connecting to extension of on-grade boardwalk (not in scope) with gated stairs to front (east) lawn
- Mechanical unit with attached enclosure below deck
- Deck has been expanded multiple times; original deck presumably comprised north, rectangular section (although it may have been smaller and squarer); 2018 expansion included south extension and ramp with level deck to connect to on-grade boardwalk (not in scope); 2024 expansion included expansion of deck connected to on-grade boardwalk and stairs to the front lawn

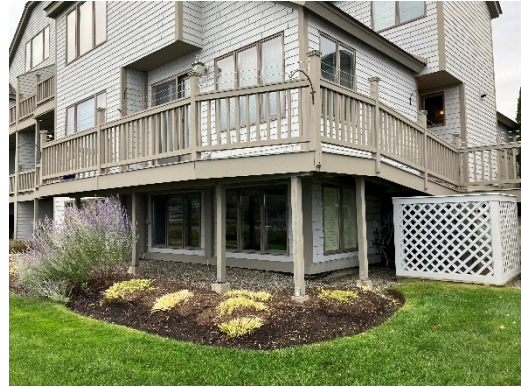
**Deck No. C9-1E/N****Configuration**

- Single level, first story, deck composed of original rectangular east deck with small inset corner at south end and a 2014 north deck expansion which connected the east deck to the north entry deck

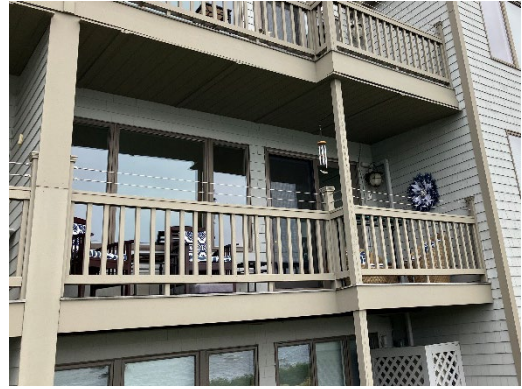
**Deck No. C10-1E****Configuration**

- First story, rectangular deck extending half the width of the building alcove with 1 deck above (C11-2E); south bay is inset approximately 1' (narrower)
- Mechanical unit with detached enclosure below deck
